OSHA-Status Report

Citations-Trades & Industry Division

5-30-14

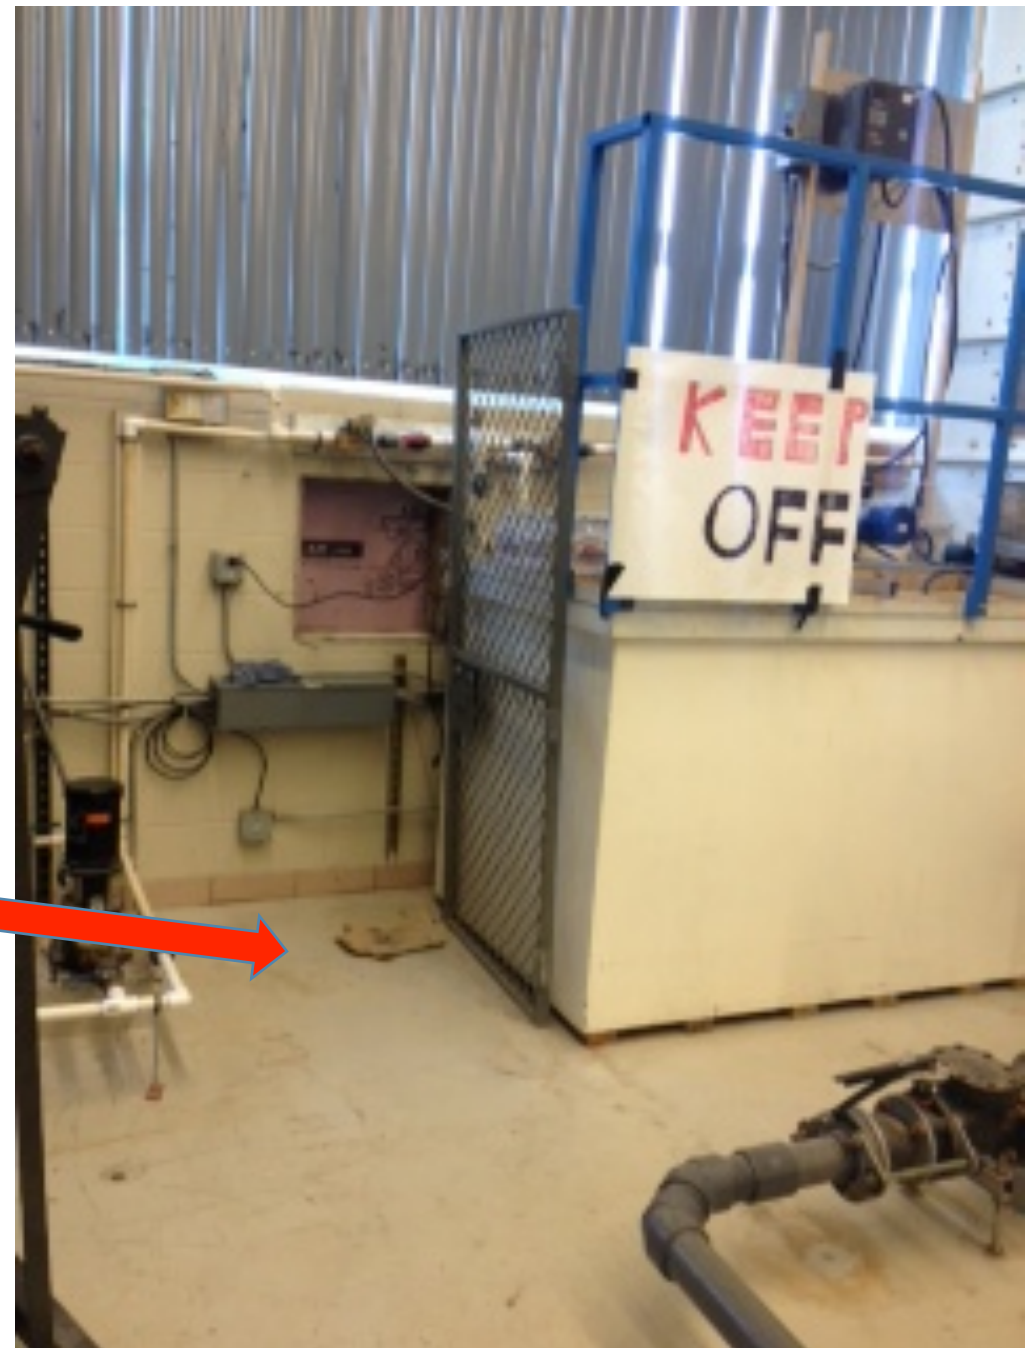
Citation 01 Item 001

Fixed Stairs did not have uniform rise height and tread width throughout the flight of stairs:

The rise height of treads on a fixed stair in the WETT Lab were not uniform throughout the flight of stairs.

- The stairs have been removed and scrapped.
- Temporary gate and sign have been added.
- New OSHA compliant stairs will be ordered before Fall semester begins.

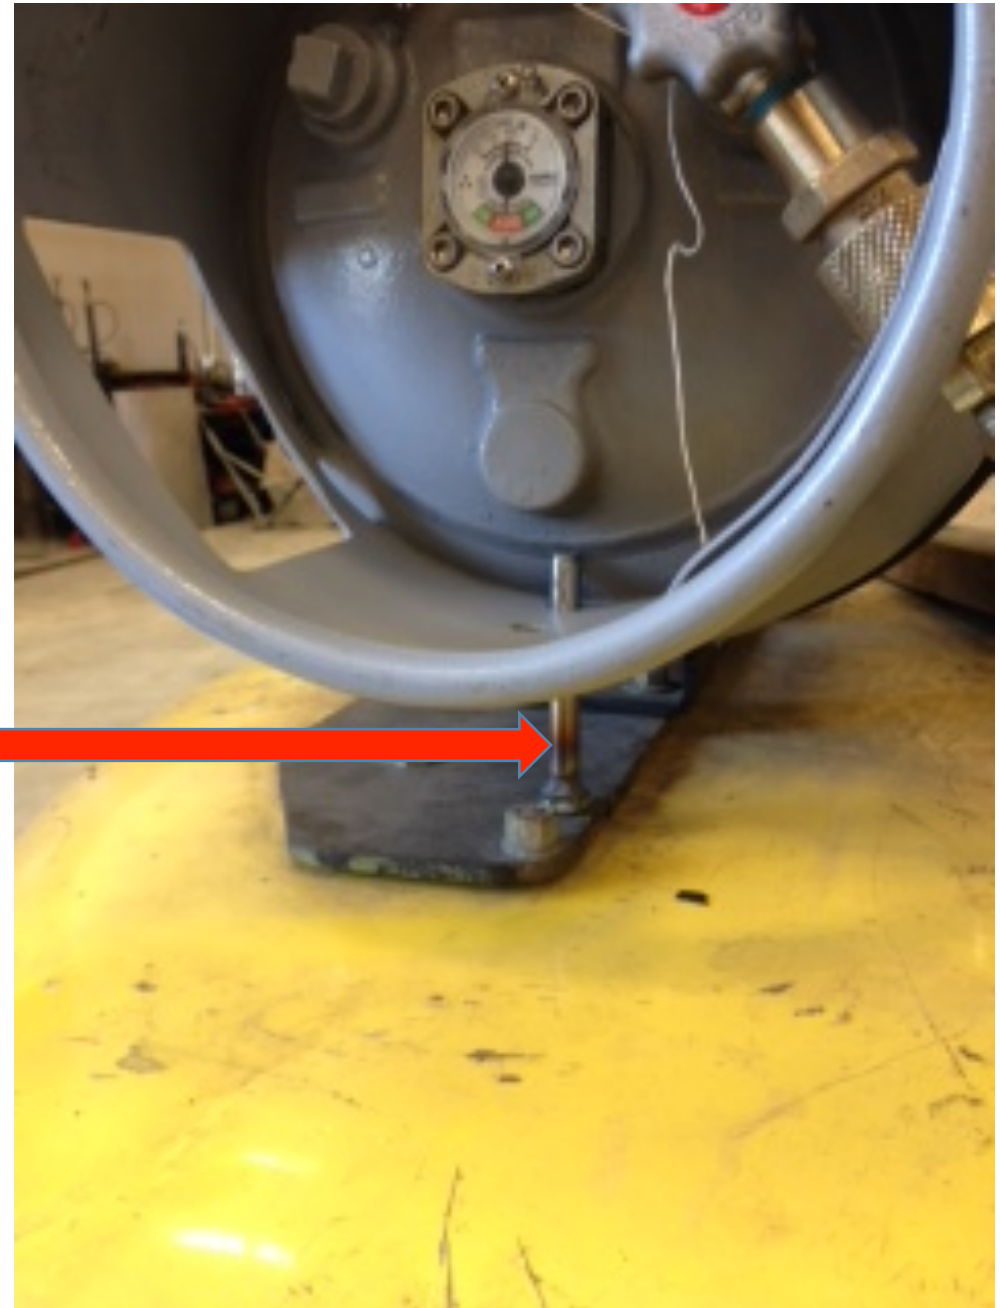
Citation 01 Item 002

LP gas container(s) installed on internal combustion engine vehicles were not securely mounted to prevent jarring loose, slipping, or rotating:

A 25 Komatsu forklift in the MHTT Lab was not equipped with an alignment pin to prevent the propane tank from rotating.

- A new pin has been mounted in place.

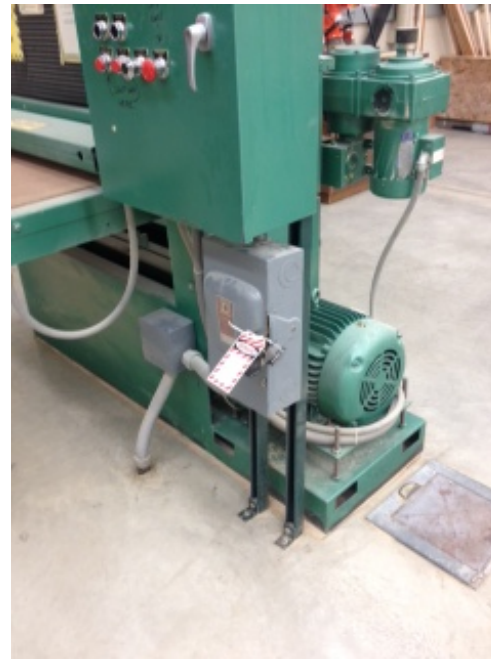
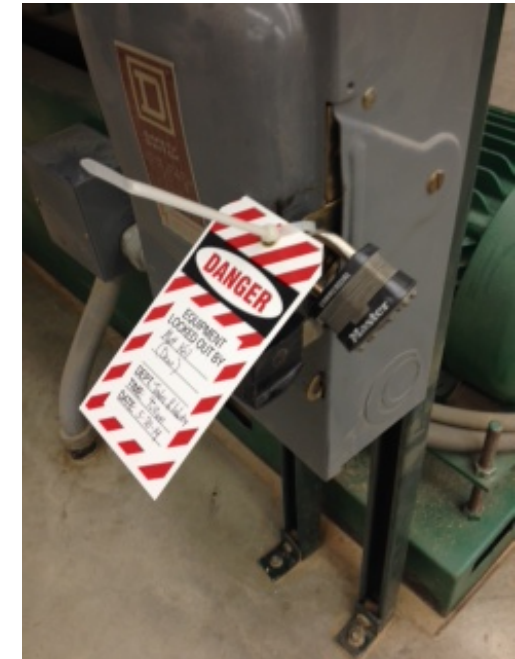
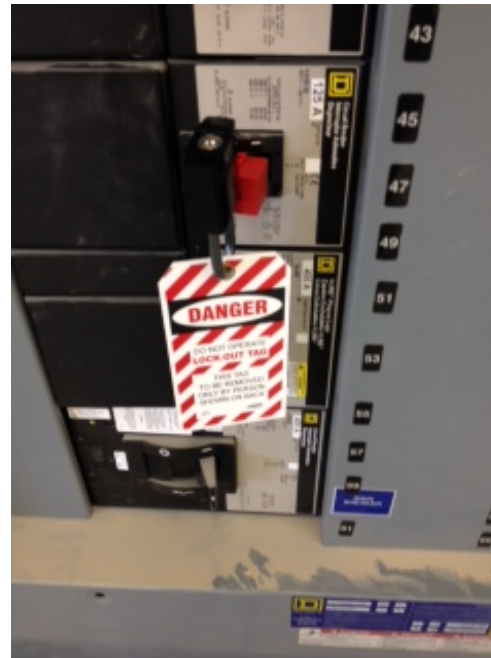
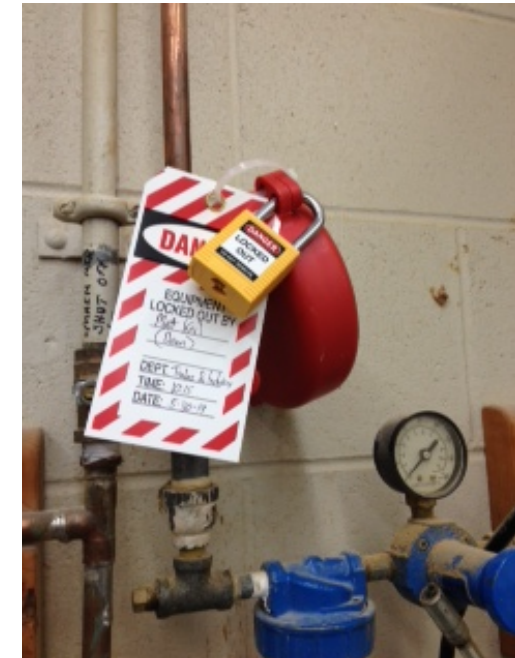
Citation 01 Item 003

Procedures were not developed, documented and utilized for the control of potentially hazardous energy when employees were engaged in activities by this section.

Machine specific lockout tagout procedures had not been developed for equipment including Timesaver Belt Sander in the Carpentry area. The procedures shall clearly and specifically outline the scope, purpose, authorization, rules, and techniques to be utilized for the control of hazardous energy, and the means to enforce compliance.

- Lockout tagout procedures are in development

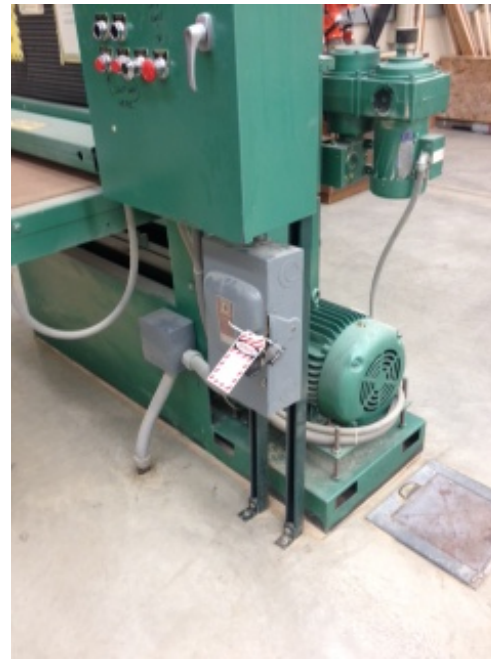
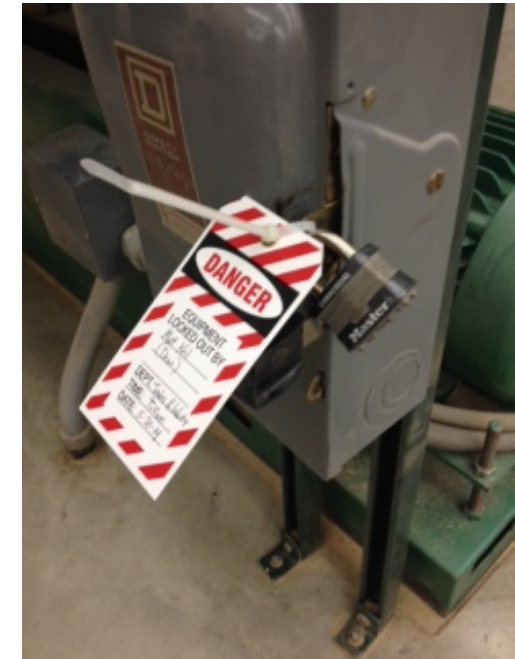
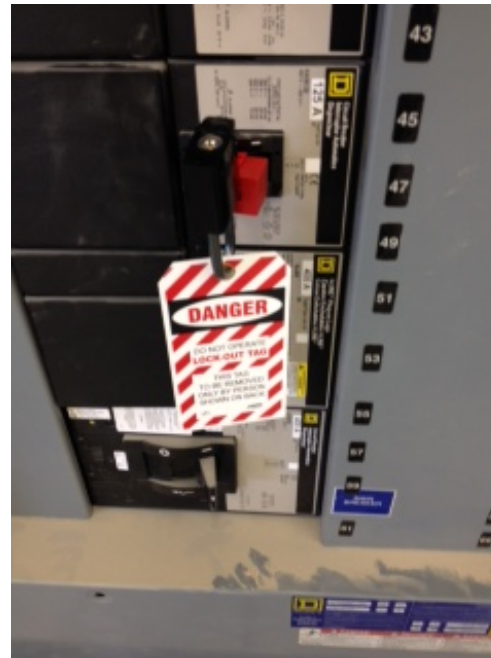
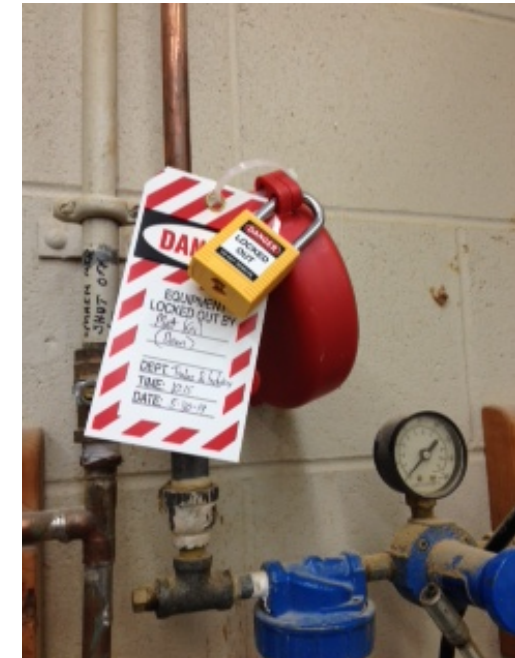
Citation 01 Item 004

The employer did not conduct a periodic inspection of the energy control procedure at least annually to ensure that the procedure and the requirement of this standard were being followed.

A periodic inspection of the energy control procedures for the timesaver Belt Sander in the Carpentry Lab was not being conducted.

- Inspection schedule is in process of being developed.
- Machine and 3 hazardous energy controls have been locked out and tagged out until proper procedures are in place.

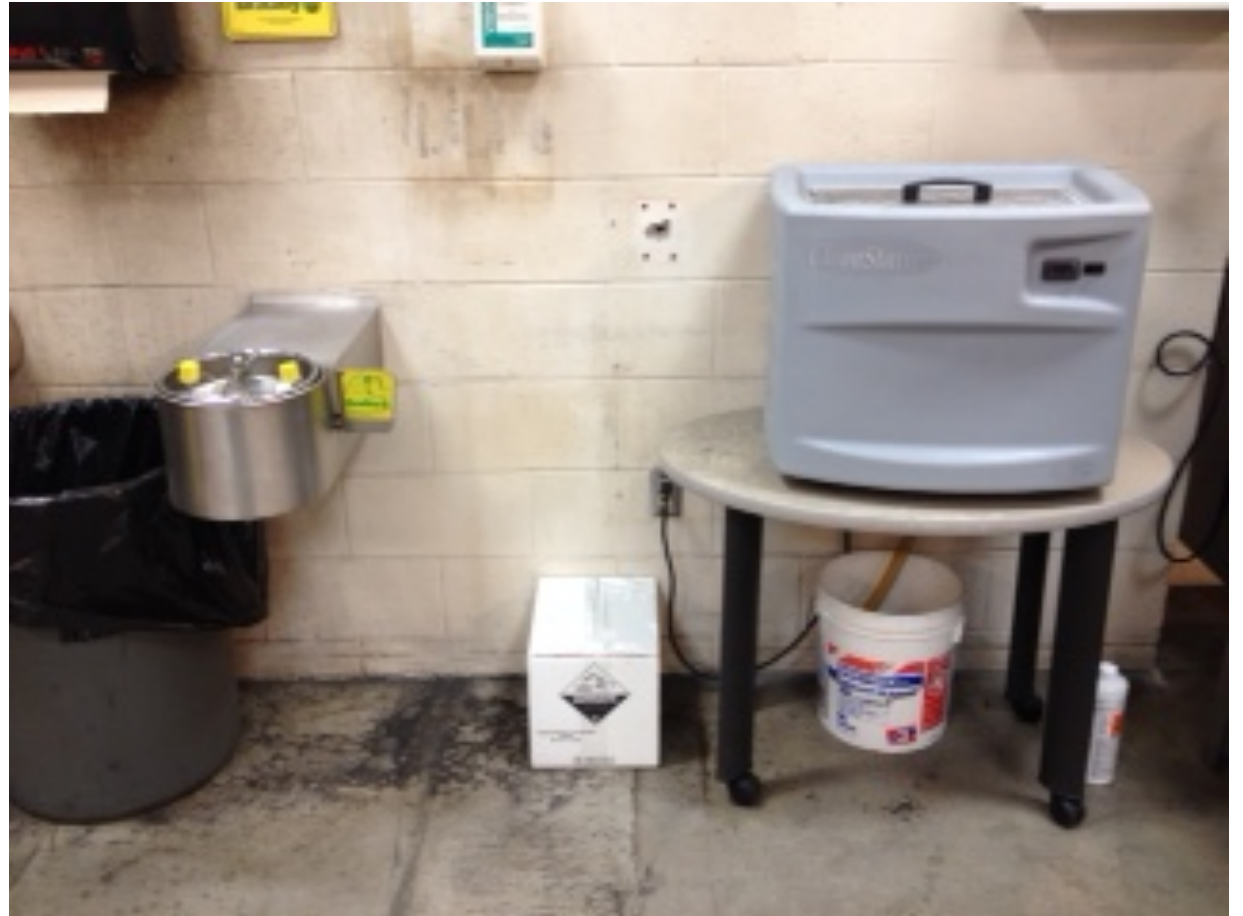
Citation 01 Item 005

Where employees were exposed to injurious corrosive materials, suitable facilities for quick drenching and flushing of the eyes and body were not provided within the work area for the immediate emergency use.

A suitable eyewash and shower were not provided in the mechanical design room where corrosive chemical named Stratasys Soluble Concentrate was being used.

- Mechanical Design machine and chemical have been moved to the Welding Lab next to a suitable eyewash station.
- This set-up will be used from this point forward and is not temporary.

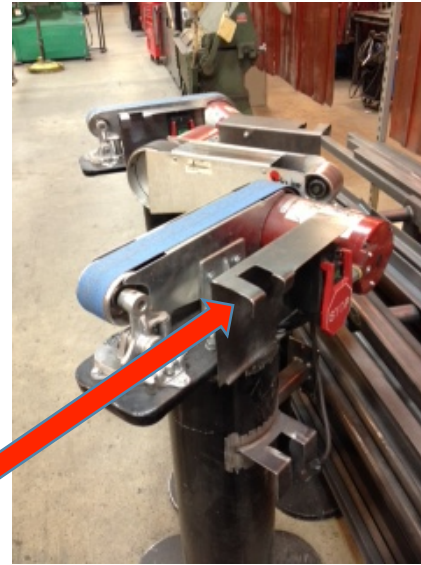
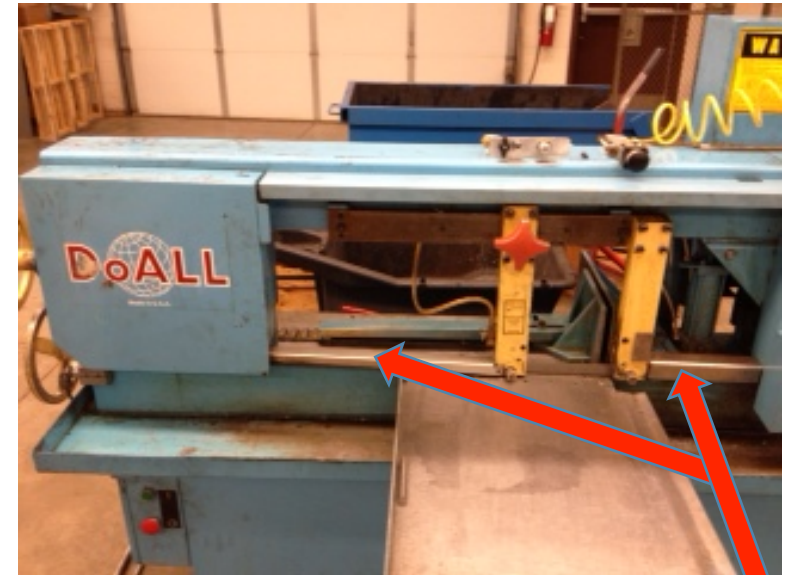
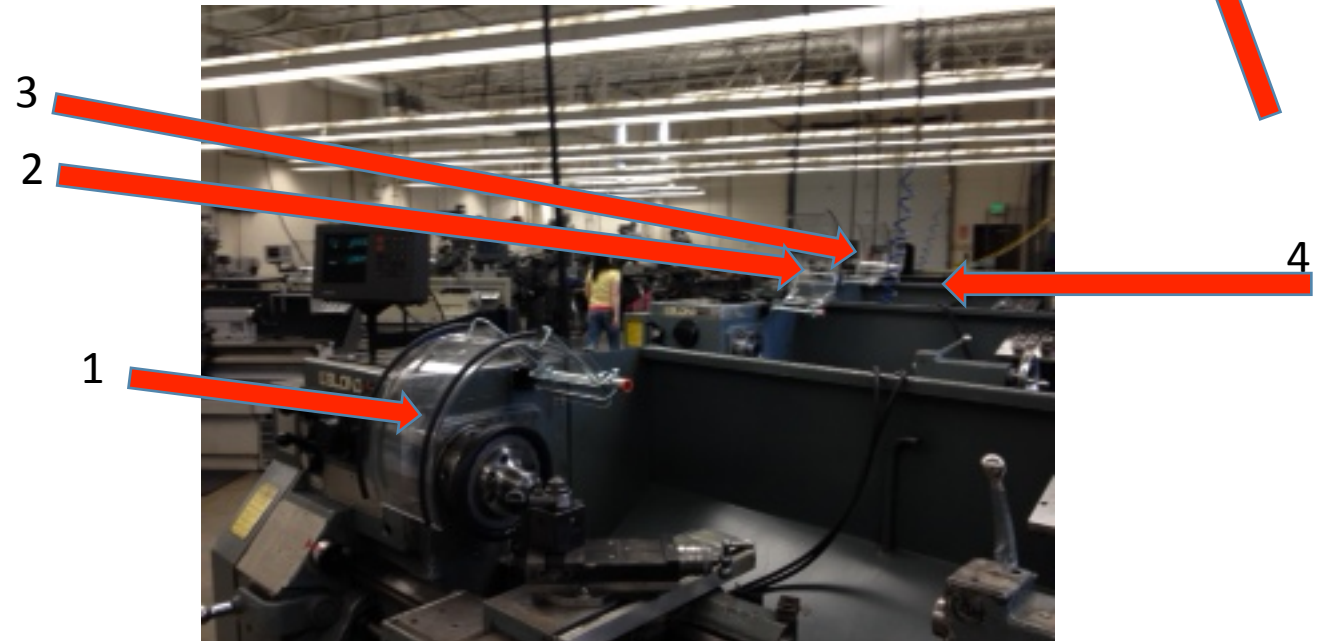
Citation 01 Item 006 29 CFR 1910.212(a) (1):

Machine guarding was not provided to protect operators and other employees from hazards created by moving machinery parts.

Machines were not equipped with guarding over moving parts or ingoing nip points including.

- a. DoAll Horizontal Bandsaw in Machine Tool Lab - proper guarding now in place.
- b. 4 Leblond and 1 DoAll Lathes in Machine Tool Lab – proper guarding now in place
- c. 3 Ickler Belt Sanders in Welding Lab – proper guarding now in place
- d. Cincinnati Gear Cutter in Machine Tool Lab – machine has been removed and sold

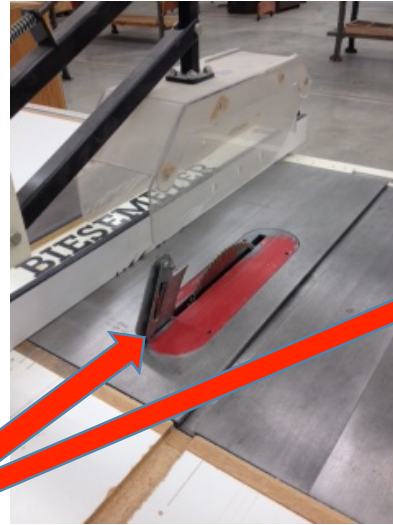
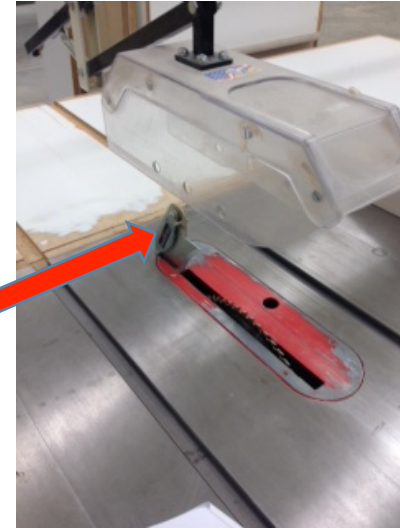
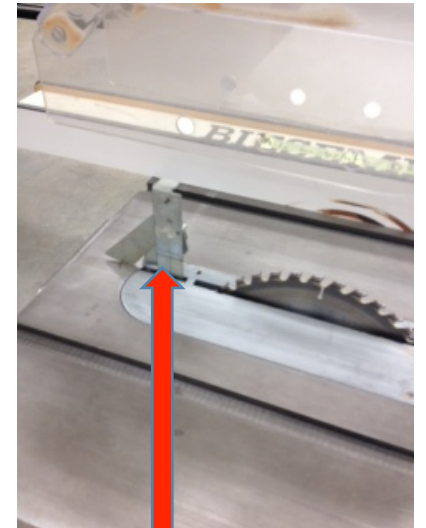
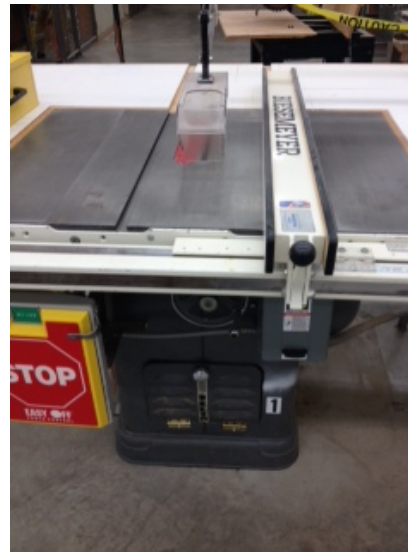
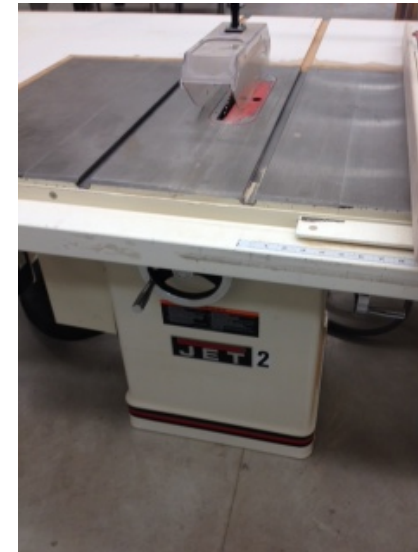
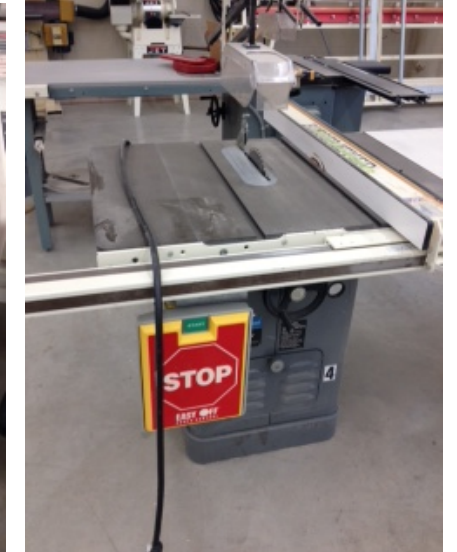
Citation 01 Item 007

Hand-fed circular ripsaw(s) were not furnished with a spreader to prevent material from squeezing the saw or being thrown back on the operator.

Rockwell Unisaw table saw and 2 Jet table saws in the Carpentry Lab area used for ripping wood boards were not equipped with a spreader device.

- Spreaders on all 3 machines are now in place and must stay there permanently.

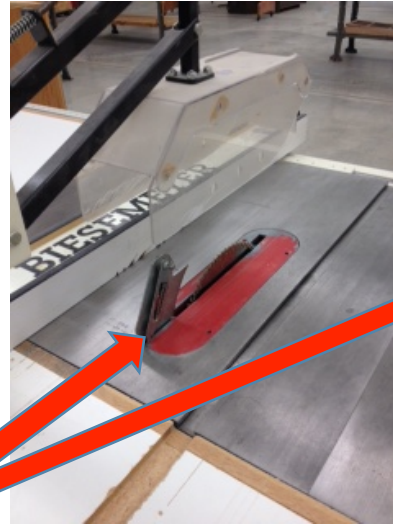
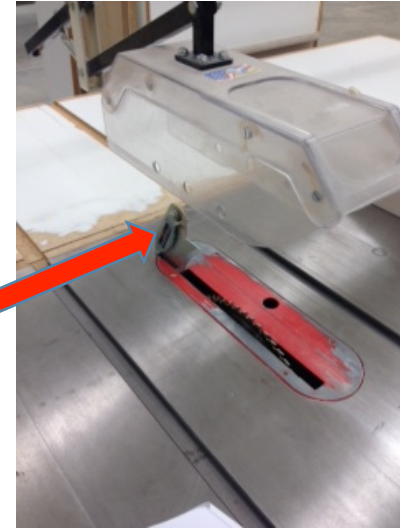
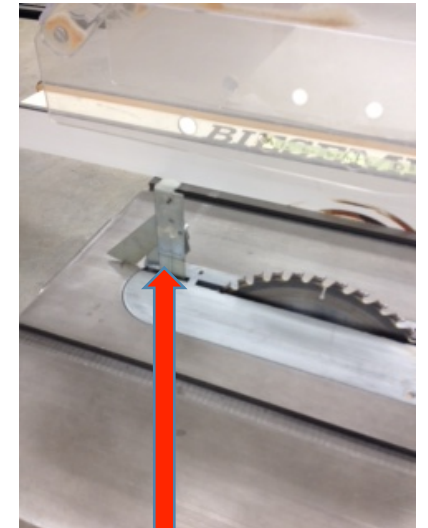
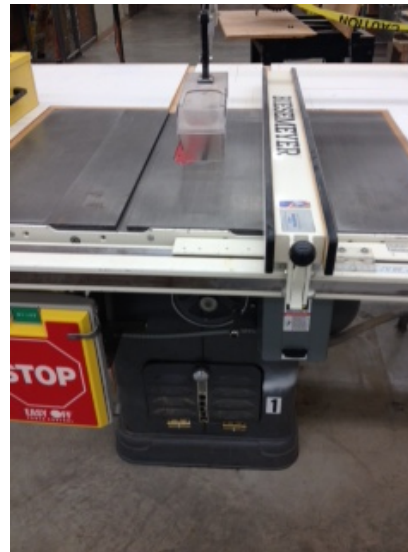
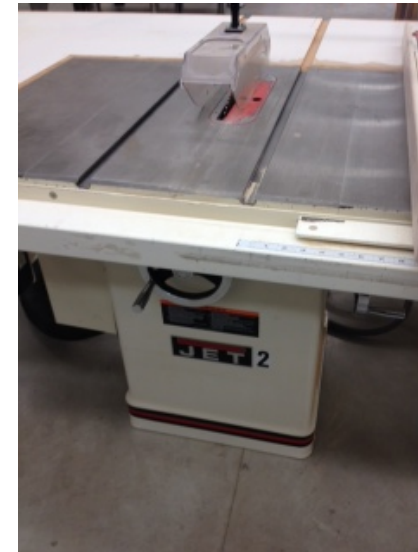
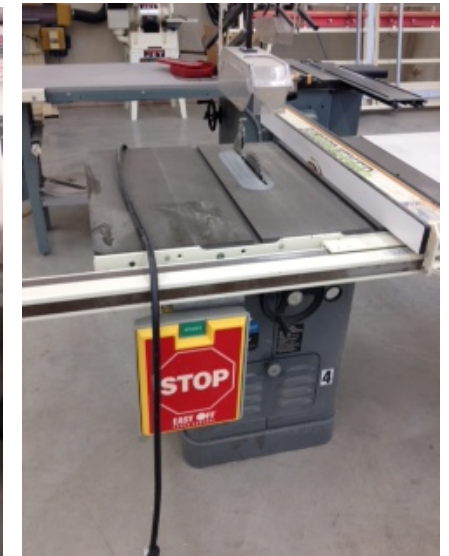
Citation 01 Item 008

Hand-fed ripsaw(s) did not have non-kickback fingers or dogs so located as to oppose the thrust or tendency of the saw to pick up the material or to throw it back toward the operator.

Rockwell Unisaw table saw and 2 Jet table saws in the Carpentry Lab area used for ripping wood boards were not equipped with a non-kickback fingers.

- Non-kickback fingers on all 3 machines are now in place and must stay there permanently.

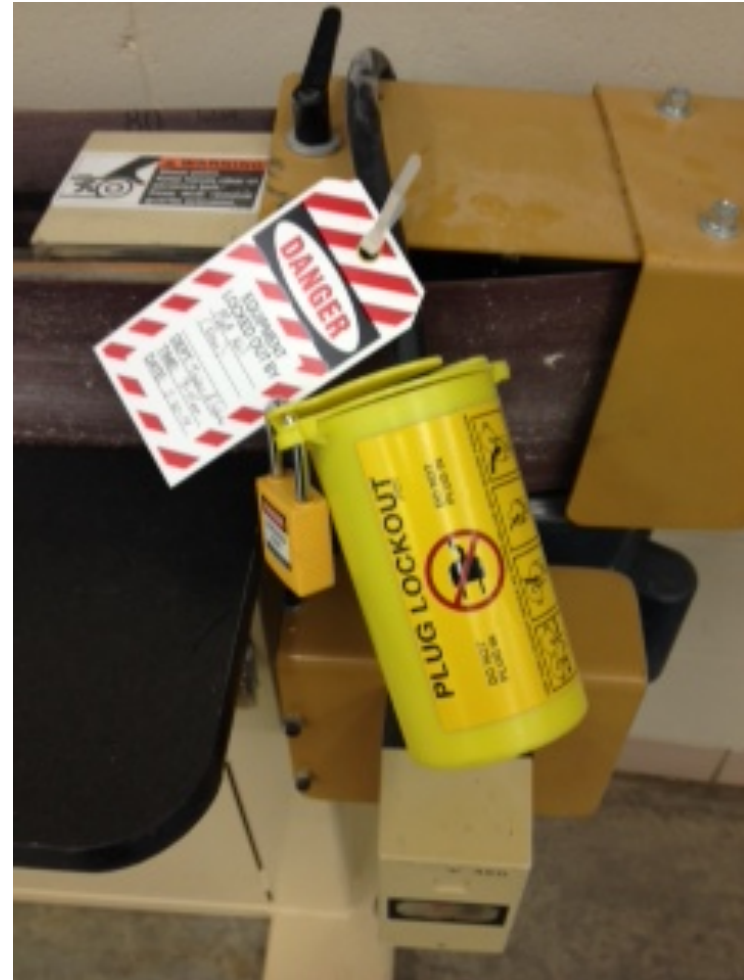
Citation 01 Item 009

Belt sanding machinery was not provided with a guard at each nip point where sanding belt ran onto a pulley, to prevent the operator's hands or fingers from coming into contact with nip points.

Ritter Belt Sander in Carpentry area used to sand wood products was not equipped with a guard at each nip point.

- Machine has been locked out and tagged out until proper guarding is in place.
- Proper guarding on one end has been installed.
- Guarding on opposite end needs to be fabricated.

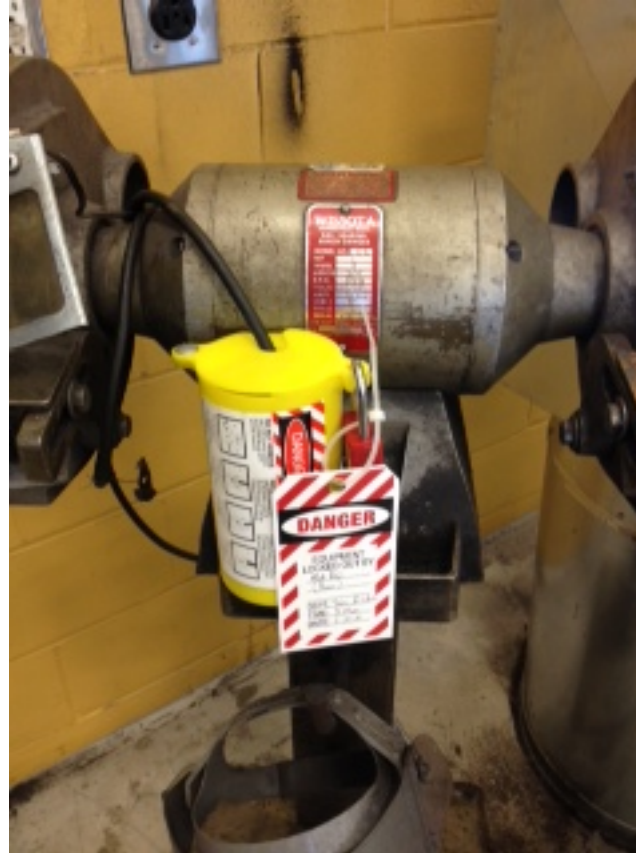
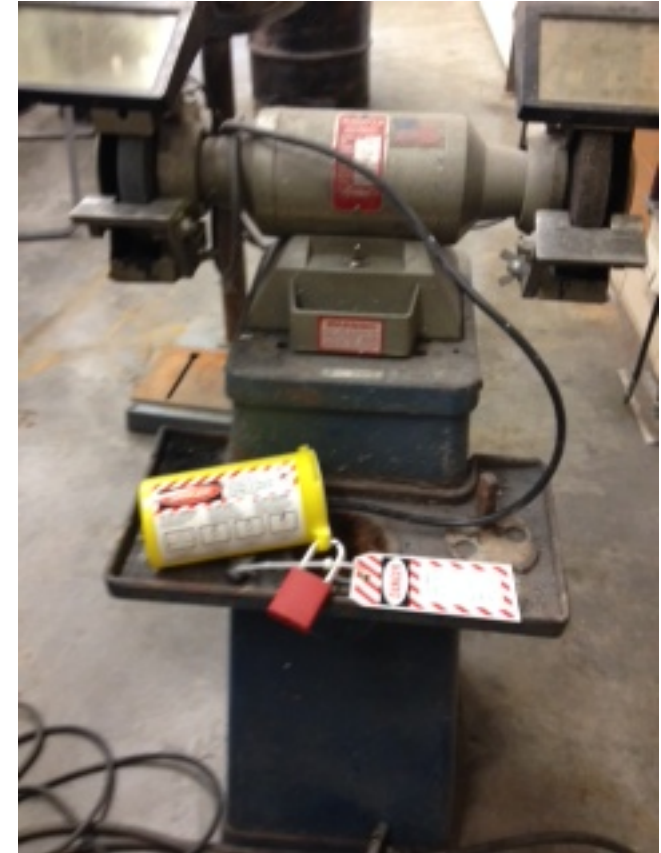
Citation 01 Item 010

Work rests on grinding machinery were not adjusted closely to the wheel with a maximum opening of 1/8 inch; and tongue guards were not adjusted closely to within 1/4 inch of the constantly decreasing diameter of the wheel.

1 abrasive wheel grinder in the MHTT Lab and 1 abrasive wheel bench grinder in the ABCT Lab did not have tool rests adjusted to within 1/8 inch of the abrasive wheel and tongue guards adjusted to within 1/4 inch of the abrasive wheel.

- Both machines have been locked out and tagged out until proper adjustments are made.
- Proper adjustments need to be made or machines will be removed permanently.

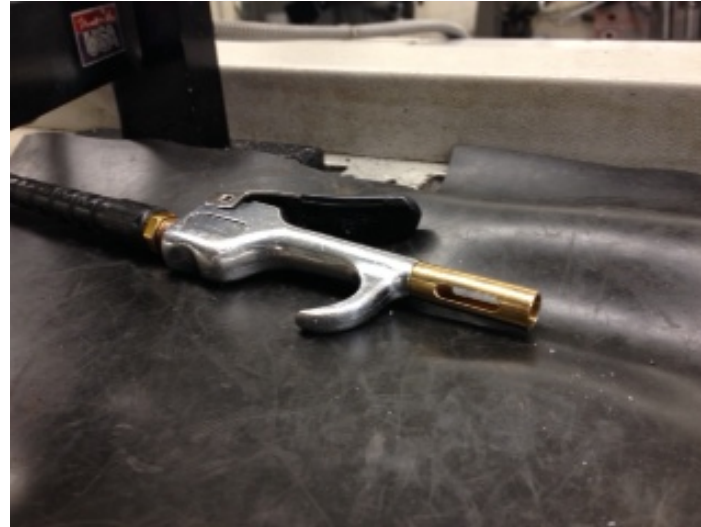
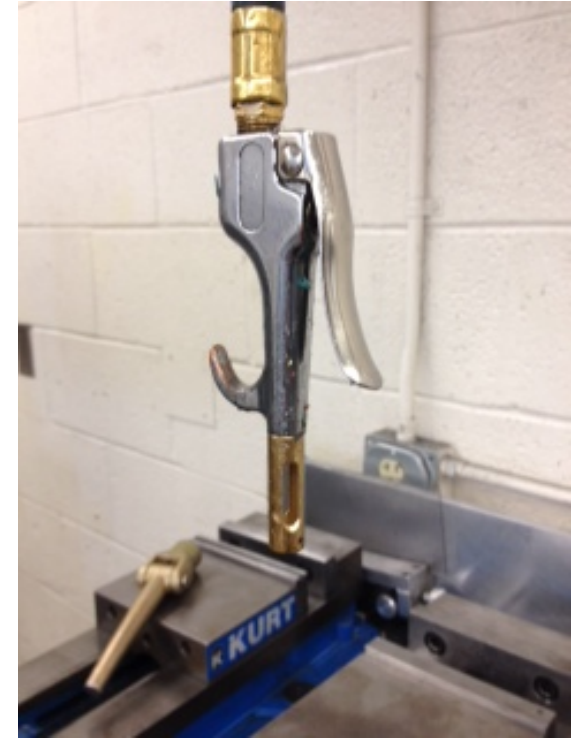
Citation 01 Item 012

Compressed air used for cleaning purposes was not reduced to less than 30psi when dead-ended.

Compressed air nozzles used for cleaning purposes in Machine Tool Lab were not reduced to less than 30psi when dead-ended.

- New nozzles have been installed.
- Air pressure needs to be checked on all lines.

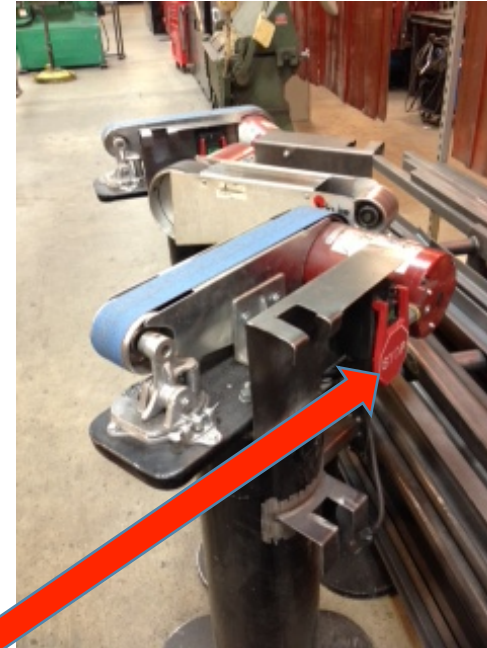
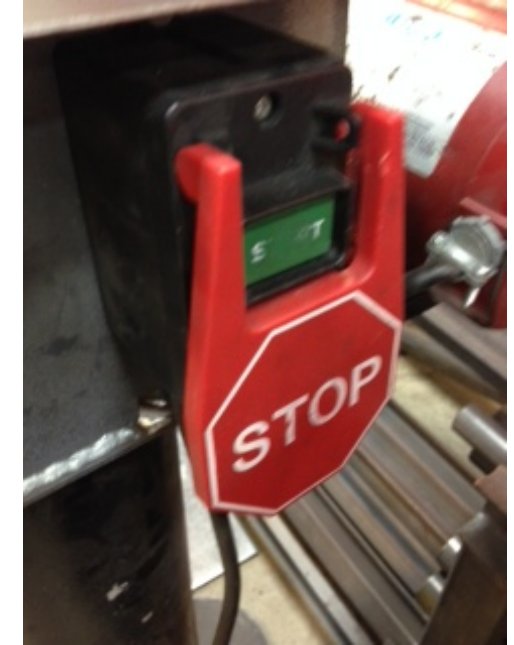
Citation 01 Item 013

Machines with point-of-operation, pinch-point, or nip-point hazards did not have motor start buttons physically protected against unintended operation.

1 Ickler belt sander in the Welding Lab had motor start toggles that were not guarded.

- Guarding has now been installed.

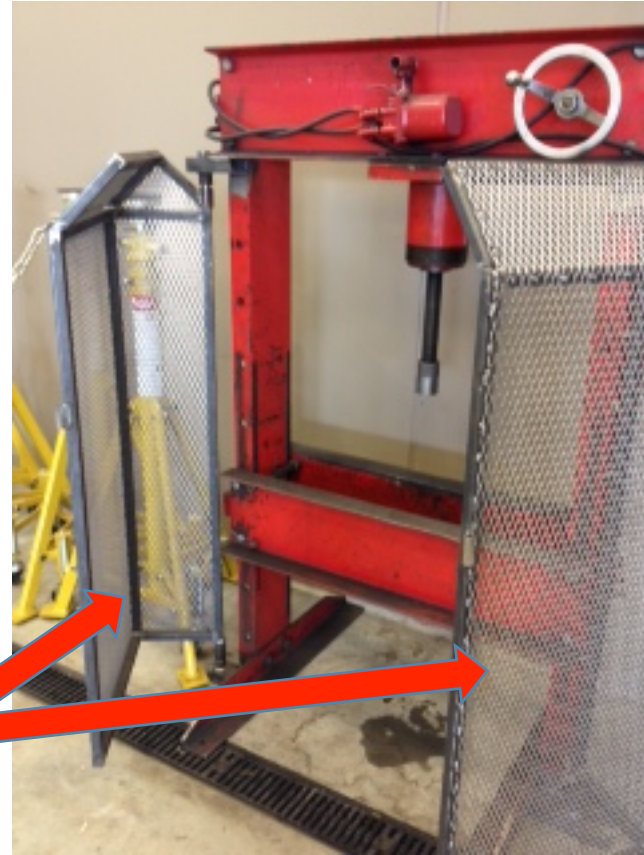
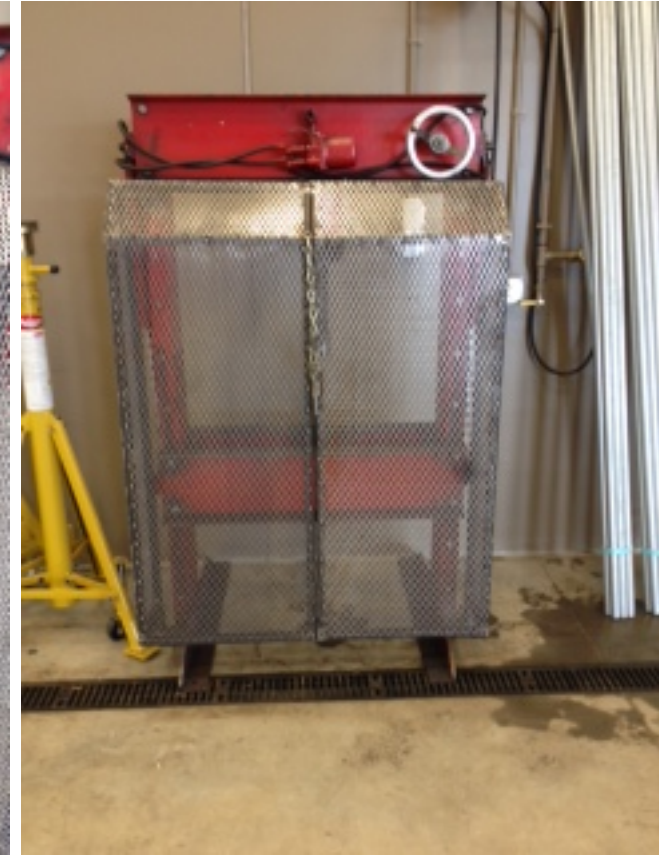
Citation 01 Item 014

Barrier guards were not maintained on hydraulic presses where there was a possibility of materials being ejected from the press.

1 hydraulic press in the MHTT Lab and 1 hydraulic press in the WETT Lab used to press bearings were not provided with adequate barrier guarding.

- Guarding has now been installed on MHTT press.
- WETT Lab press has been removed from SCTCC and sold. MHTT will allow WETT to use their press in the future if needed.

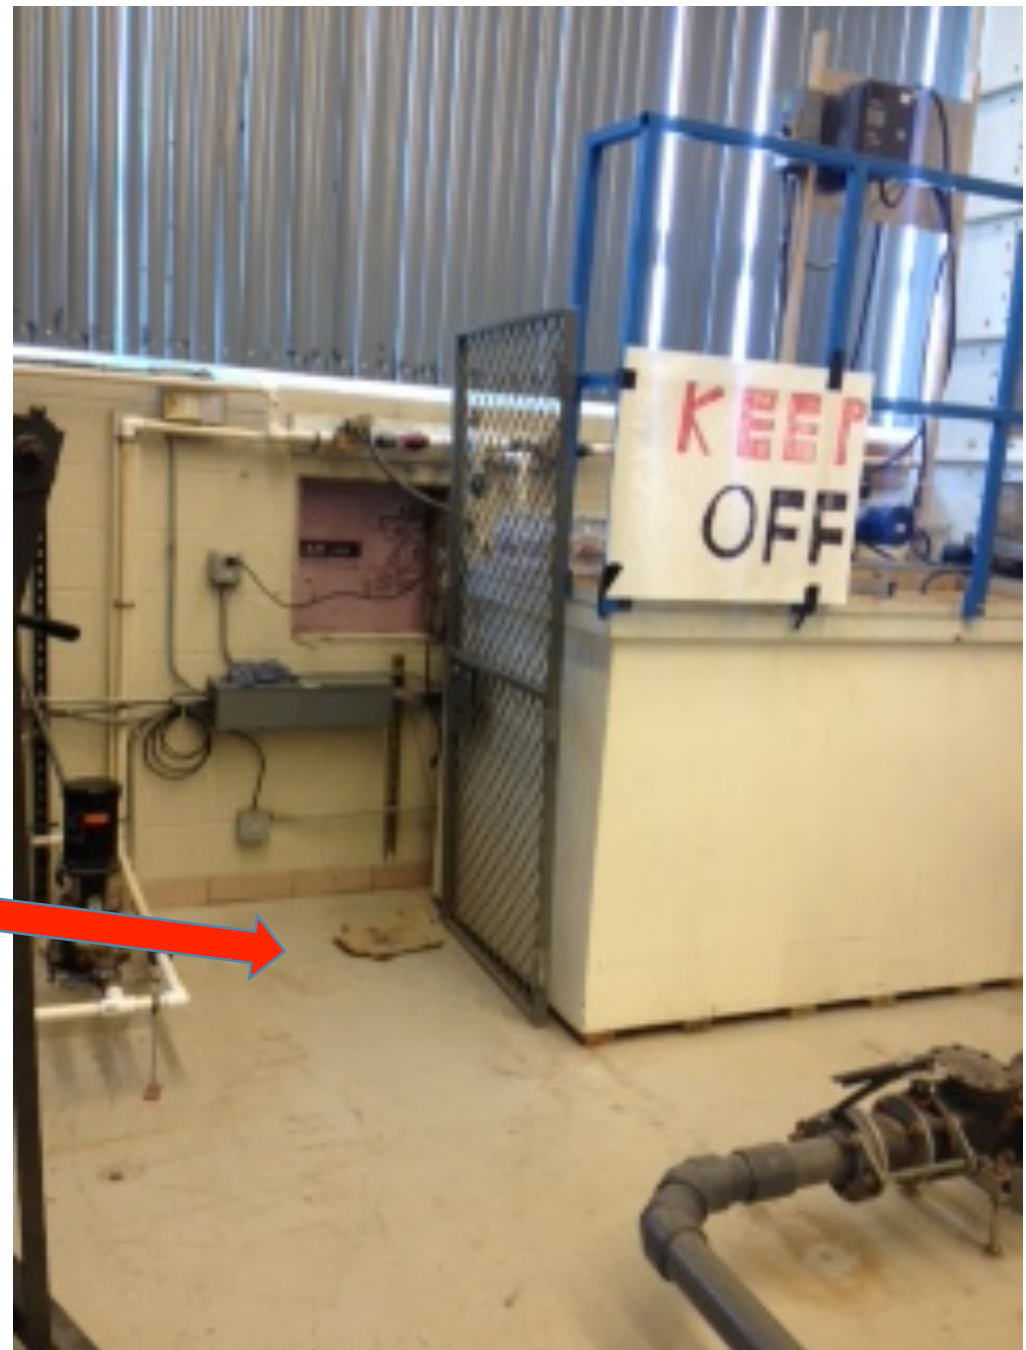
Citation 02 Item 001

The vertical height of a stair railing was installed between 34 and 30 inches from upper surface to top rail to surface of tread in line with face of riser at forward edge of tread.

Stair railing on a fixed industrial stairway leading up to a variable speed pump in the WETT Lab was not installed between 34 and 30 inches.

- The stairs have been removed and scrapped.
- Temporary gate and sign have been added.
- New OSHA compliant stairs will be ordered before Fall semester begins.

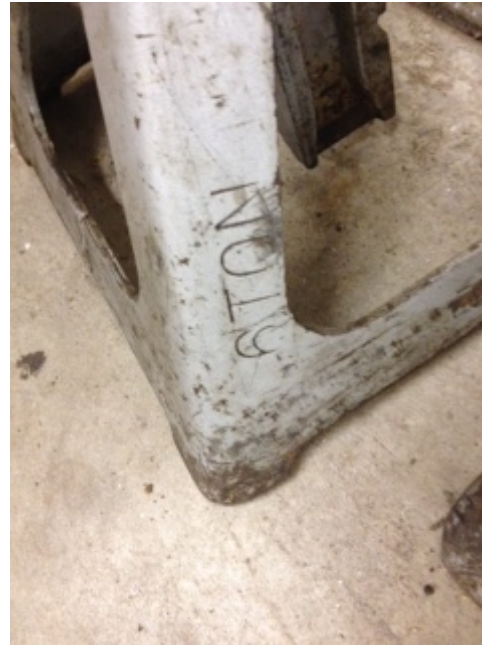
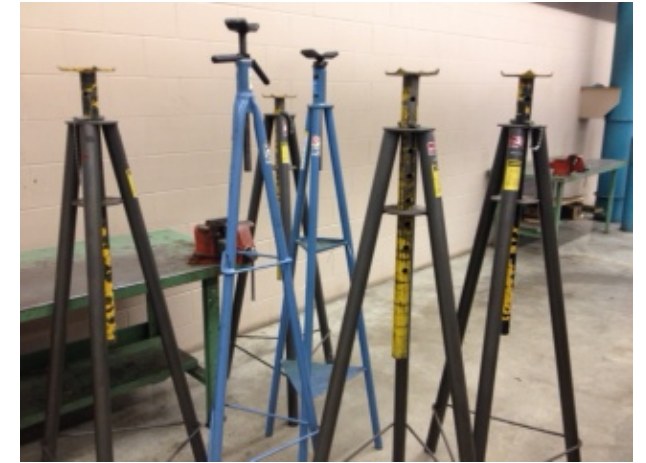
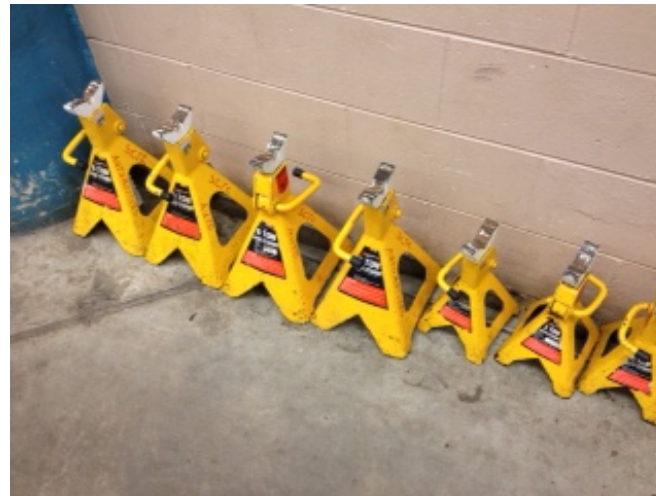
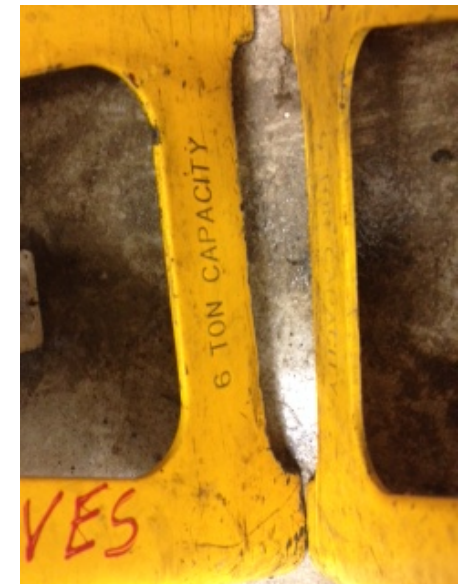
Citation 02 Item 003

Rated load(s) of portable jack(s) were not legibly and permanently marked in a prominent location on the jack(s) by casting, stamping, or other suitable means.

2 floor jacks in the MHTT Lab and 2 floor jacks in the Auto Lab were not marked with load rating.

- All jacks with no load rating markings were removed from SCTCC and scrapped.
- Only jacks with proper markings remain in labs.

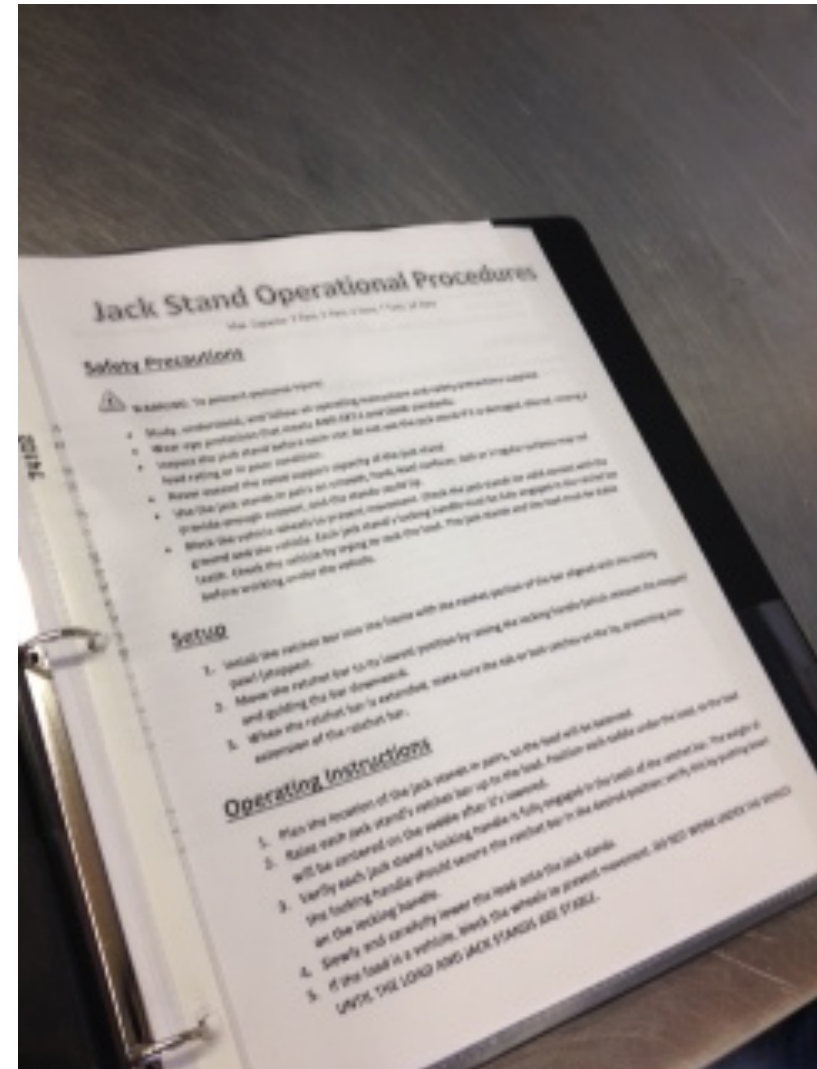
Citation 02 Item 004

Portable jacks were not inspected at times which depend upon service conditions as outlined in sub paragraphs a, b, c of the chapter.

Multiple jacks in the MHTT and Auto Labs were not being inspected.

- Operational and inspection procedures have been developed and are now in place.
- A timeline for inspections has been established.
